The ICOMOS methodology for conservation of cultural heritage buildings: concepts, research and application to case studies

P. B. Lourenço

3 THE WORKS AT CATHEDRAL OF PORTO

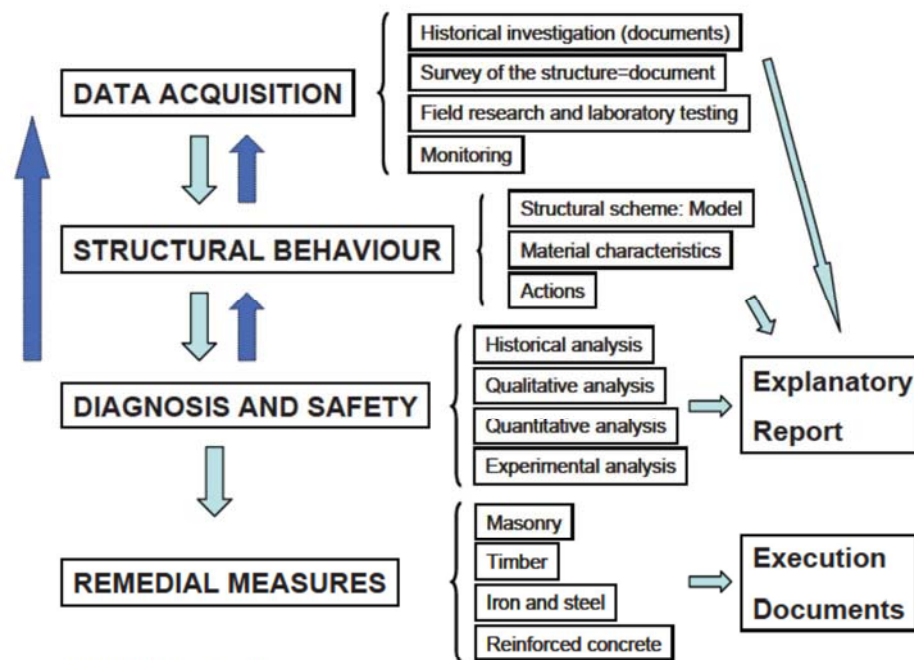
Figure 1. ICOMOS methodology.

In general the process towards the definition of remedial measures should include the following steps: (a) Acquisition of data: Information and investigation; (b) Historical, structural and architectural investigations; (c) Survey of the structure; (d) Field research and laboratory testing; (e) Monitoring, see Figure 1. Diagnosis and safety evaluation of the structure are two consecutive and related stages on the basis of which the effective need for and extent of treatment measures are determined. If these stages are performed incorrectly, the resulting decisions will be arbitrary: poor judgment may result in either conservative and therefore heavy-handed conservation measures or inadequate safety levels. Any assessment of safety is seriously affected by the uncertainty attached to data (actions, resistance, deformations, etc.), models, assumptions, etc. used in the research, and by the difficulty of representing real phenomena in a precise way.

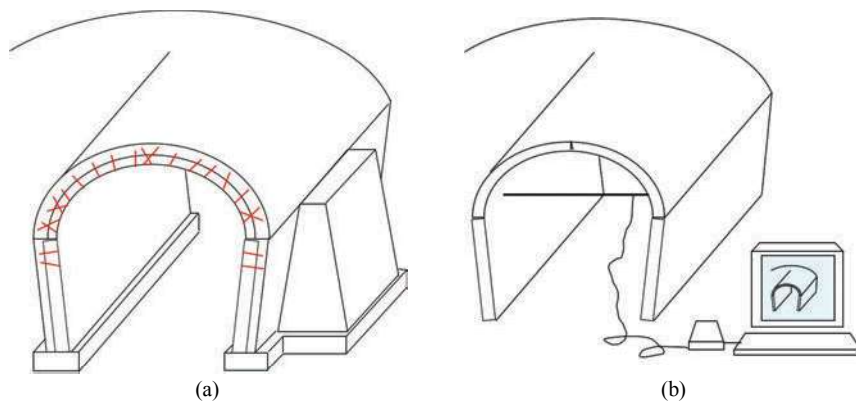
Figure 2. Two approaches in conservation: (a) past understanding; (b) present understanding.

The proposed methodology is in opposition with the past understanding, in which “conservation” was usually warranted by the powerfulness of the intervention, blind confidence existed in modern materials and technologies, a mistrust was present towards original or ancient materials and original resisting resources of the building, the value of original / ancient structure and structural principles was not recognized, the importance of previous studies was not fully recognize and significant negative experience accumulated, see Figure 2a. The modern understanding is to respect the authenticity of the structure and structural principles governing its response, to believe that conservation should lie on knowledge and understanding of the nature of the structure and real causes of possible damage or alterations, to adopt respectful interventions (minimal, non-intrusive and reversible), to give importance to knowledge (comprising historical, material and structural aspects) and to assume that studies prior to intervention and the intervention are multidisciplinary tasks requiring the cooperation of historians, architects, engineers, physicists, among others, see Figure 2b. These aspects are further discussed below.

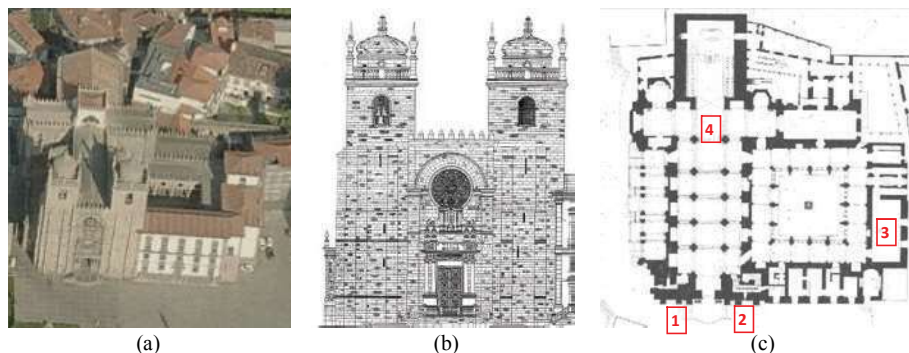
Figure 3. Aspect of the Cathedral: (a) Aerial View; (b) Façade; (c) Plan. Legend: 1 – North Tower; 2 – South Tower; 3 – St. Vincent Chapel; 4 – Skylight.

Figure 3 shows selected views of the compound of the Cathedral, which has dimensions about 60×60 m² in plan, with a maximum height of the towers about 35 m. The compound includes the church, a gothic cloister on the south side, side chapels, a gallery on the north side, a sacristy, several chapels and other annexes. The church has a typical Latin cross, with three naves and five spans, and two rectangular towers facing west.

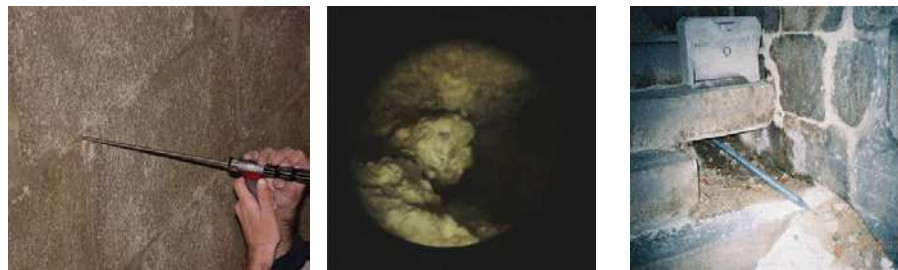
Figure 4. Visual inspection with boroscopic camera and inspection openings.

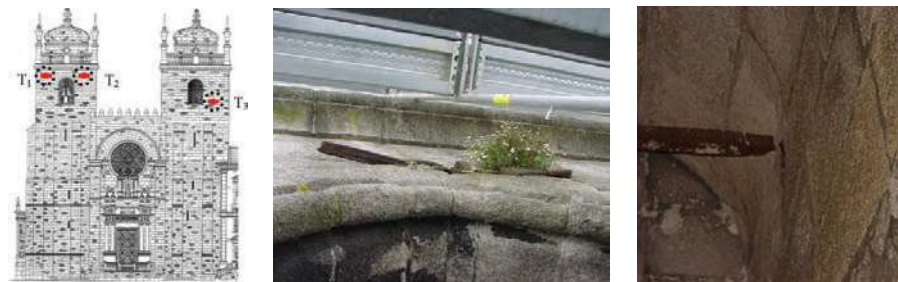
Figure 5. Ancient tower ties, with deformed anchorage (T1) and broken tie (T3).

The towers exhibit distributed cracking and significant out-of-plane movements. The existing damage resulted in the past addition of three iron ties (date unknown), see Figure 5. Tie T1 presents a severely deformed anchorage and tie T3 is corroded and broken. The separation between the East and West façades of the South tower continued after tie T3 was broken. The masonry walls in the vicinity of the anchorages are also deformed, as expected due to the application of a large point load. The South tower is more damaged than the North tower, with severe cracks and out-of-plumb walls. Separation between the internal and external leaves of the walls is confirmed by the longitudinal cracking observed in most of the openings, with a maximum width of some centimeters.

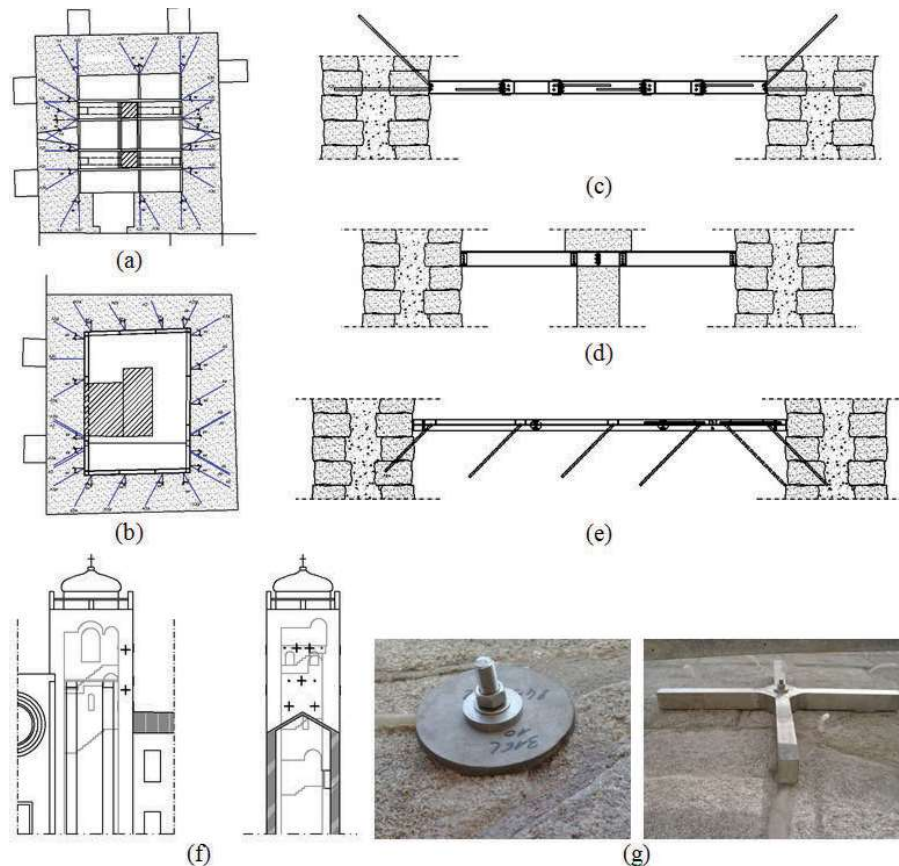
Figure 6. Aspect of the strengthening of the towers: (a) Ring for the north tower; (b) Ring for the south tower; (c) North-south section for north tower; (d) West-east section for north tower; (e) Typical section for south tower; (f) Additional ties in the west and south façades of the south tower; (g) Details of the anchorage plates.

The solution adopted for strengthening consists mostly of a steel ring in both towers, aiming at confining the structure along the two orthogonal directions, in the sole location possible, see Figure 6a, b. The rings are made with welded stainless steel plates (class AISI 316L), connected to the towers using long, inclined stainless steel anchorages inside of a cloth duct to prevent generalized injection, see Figure 6c-e. The length of the steel profiles is defined so that the elements can be transported to the location through the existing doors and can be easily assembled in situ, without any further welding. In the North tower, the ring also aims at providing a support for the stone pavement for the bells, as stone columns are much deteriorated and had no structural function and the stone struts have very deficient conception. The steel ring is made of channel profiles (240×120 mm and 200×100 mm height). In the South tower, a set of two ties was provided to the ring, because it was possible for aesthetic reasons and they are a testimony of the ancient broken tie. The ring must cross the staircase at a selected location because the complex internal structure of the tower does not allow otherwise. Due to the lack of internal stiffening elements, a much stiffer steel frame is needed and the steel ring is made of H profiles (180×180 mm). Due to the bulging outwards of the East and South façades, and the severe cracks in the corners, several short ties have been added to the structure to stitch the East and South façades, and two long ties through the core of the South façade have been added to connect the West and East façades, see Figure 6f. Figure 6g presents details of the two types of anchorage plates adopted (circular plates and specially designed crosses).

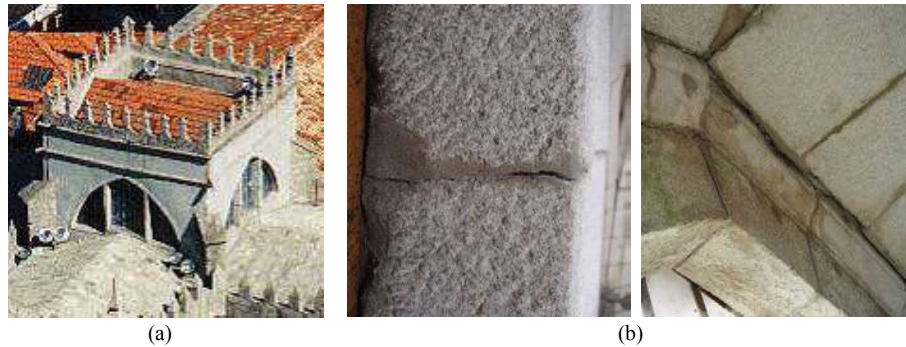
Figure 7. Skylight: (a) Aerial view; (b) Cracks in windows columns and vaults.

The three walls with windows are cracked at the arch key, with maximum crack widths of 10, 1 and <0.5 mm, in the façades West, North and South, respectively. These walls are also bulging outwards. Figure 7b shows the main crack in the West façade, which crosses the entire section of the wall. Smaller cracks can be also observed closer to the buttresses, under the opening, together with horizontal cracks in the window columns due to bending. The most severe crack in the interior has a width of 25 mm and shows that the vault is separated from the wall in the West façade. Due to this crack, the stone slabs of the vault are no longer supported in the side rib and a settlement of about 20 mm can be observed at the key of the vault.

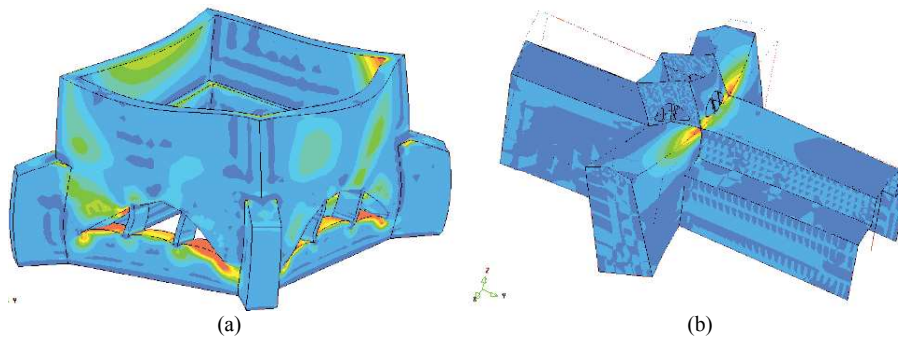
Figure 8. FEM analysis: (a) Live loads; (b) Dead load for full model.

The observation of the damage in the skylight, together with the local relief, the severe separation between the East façade and the chancel, the old documents indicating consolidation and enlargement of foundations and the bulging of the walls of the nave indicate that soil settlements and weak foundations can be the main cause of damage. A finite element model of the skylight was used to understand and justify the existing damage. The actions considered include the self-weight of the structure, the weight of the infill, the seismic action and differential temperature. The results for the combination of self-weight plus rubble infill provided a maximum tensile stress found lower than 0.1 N/mm² and located in the window-sills and ribs. The skylight should have minor or no damage under self-weight and infill. Seismic loading and temperature were then added to the structure, aiming at explaining the damage, see Figure 8a, b. Even if the deformation for seismic loading has some resemblance with the observed movements in the structure, the stresses found are too low to provoke any damage. The deformed mesh associated with the differential temperature indicates that the walls move to the exterior and suffer significant bending, with significant curvatures in the columns. Still moderate stresses are found and the deformation is not in agreement with the observed movements, meaning that the temperature effect is relevant but should not be the main cause of the damage. A full model of the church was then prepared to analyze the influence between the skylight, the adjacent structure and the soil, see Figure 8b. Very high tensile stresses are found in the skylight and the deformation is similar to the one observed in the structure, confirming that this is the major cause of damage. The remedial measures are given in Lourenço et al. (2004).
